Summer 2018

50 Years and Strong!

Willamette Valley Vineyards Reservoir

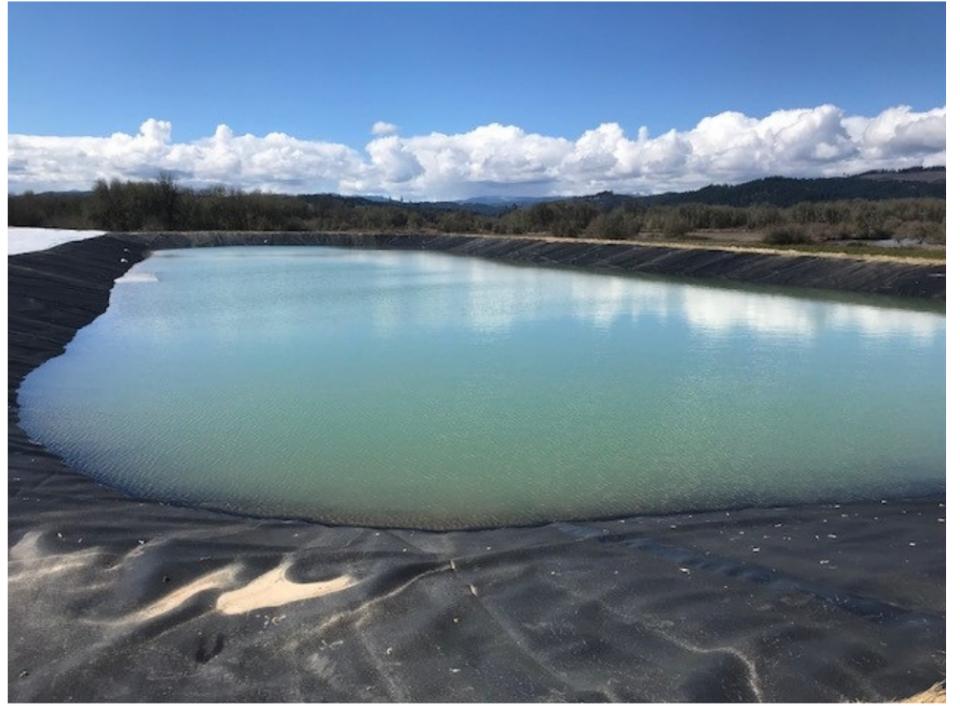
Construction of the reservoir commenced in early September and was completed mid-October, 2017 by Parker Pacific Development, LLC under the company's excavation division. Approximately 19,000 cubic yards of earthwork was required to construct the earthen embankment, core trench, and emergency overflow spillway. Wetland Solutions Northwest, LLC. completed wetland delineation, reporting, permitting, and mitigation design. GEO Consultants Northwest, Inc. completed geological review and analysis of soils prior to and during construction.

The Willamette Valley Vineyards Reservoir is located approximately 1.6 miles northeast of Gaston, Oregon and is west of the intersection of SW Vandehey & SW Spring Hill Road. The reservoir stores 6.2 acre-feet of water for the purpose of irrigation, aesthetics, fire prevention, recreation and wildlife. The footprint of the reservoir at normal pool is approximately 0.9 acres. The earthen dam is trapezoidal in shape with three sides as earthen embankment and the one side as a cut into a rolling hill. The dam embankment is approximately 13' tall, 650' long, and 16' wide. The reservoir is lined with plastic and is filled by collecting runoff from precipitation. A 0.7 acre plastic-lined 'rain collection area' adjacent to the reservoir collects precipitation and conveys it by gravity to the reservoir.

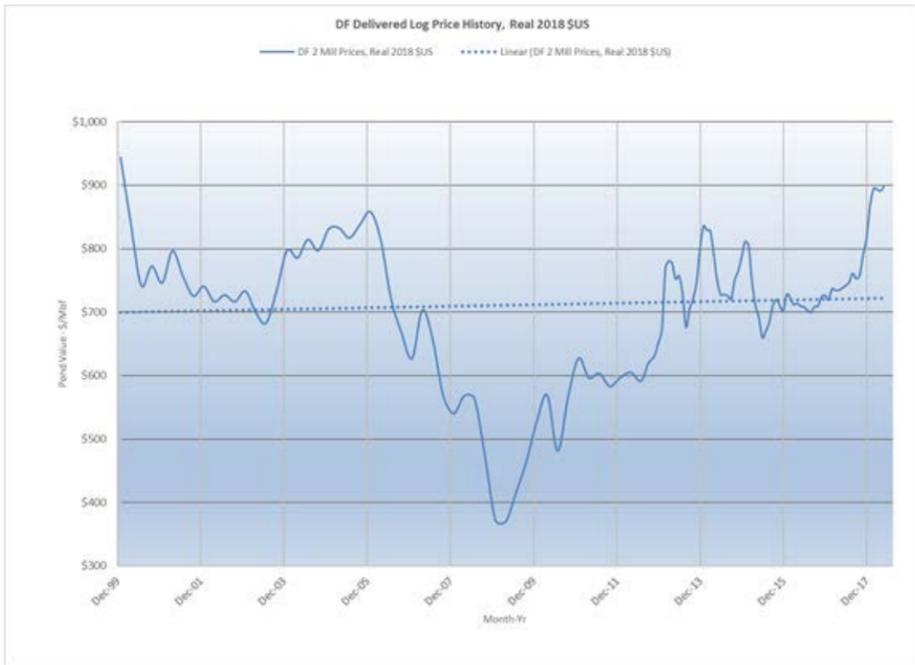
Figure 1 is a graph of graph of Douglas-fir 2 mill log prices between 2000 and 2018. Inflationary impacts have been factored out using a Consumer Price Index adjustment to convert historical prices to a 2018 dollar equivalent. As can be seen in this graph, prices at the beginning of the period were just coming off the 1990's spotted owl influenced prices. Typical fluctuations in the markets can be seen through most of the last 18 years with the exception of the 2008 recession period where prices dropped dramatically. You can see that current log prices are above normal high points by around \$50/MBF.

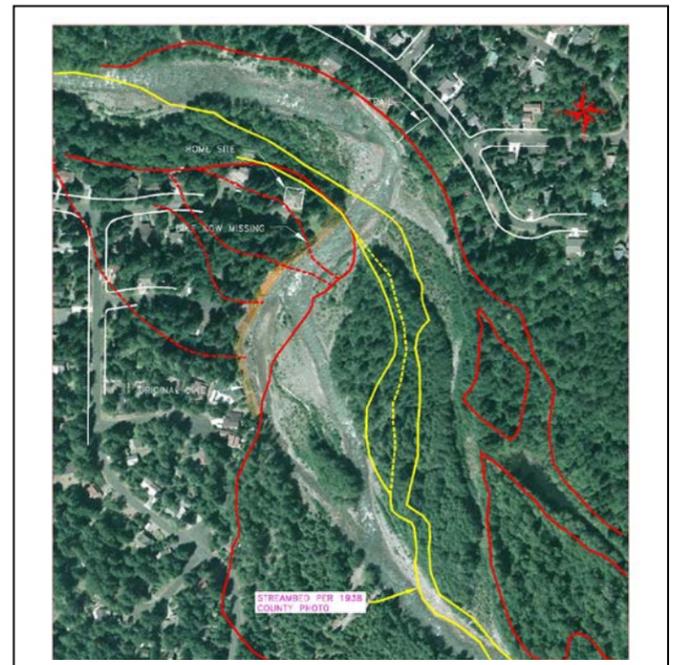
Sandy River Channels from 1938-2008

Water has been known to move land, both quickly and imperceptibly. If it happens slowly as in accretion, an adjacent owner may slowly increase the amount of land they own. If it happens in a very fast, perceptible action it is generally determined to not affect boundaries.
